N00019-78-C-0065

"AN INVESTIGATION OF MECHANISMS EFFECTING
ENVIRONMENTAL STRESS CRACKING IN TITANIUM ALLOY"

January 20, 1979

Mechanical Engineering Department
Southern University
Baton Rouge, Louisiana 70813

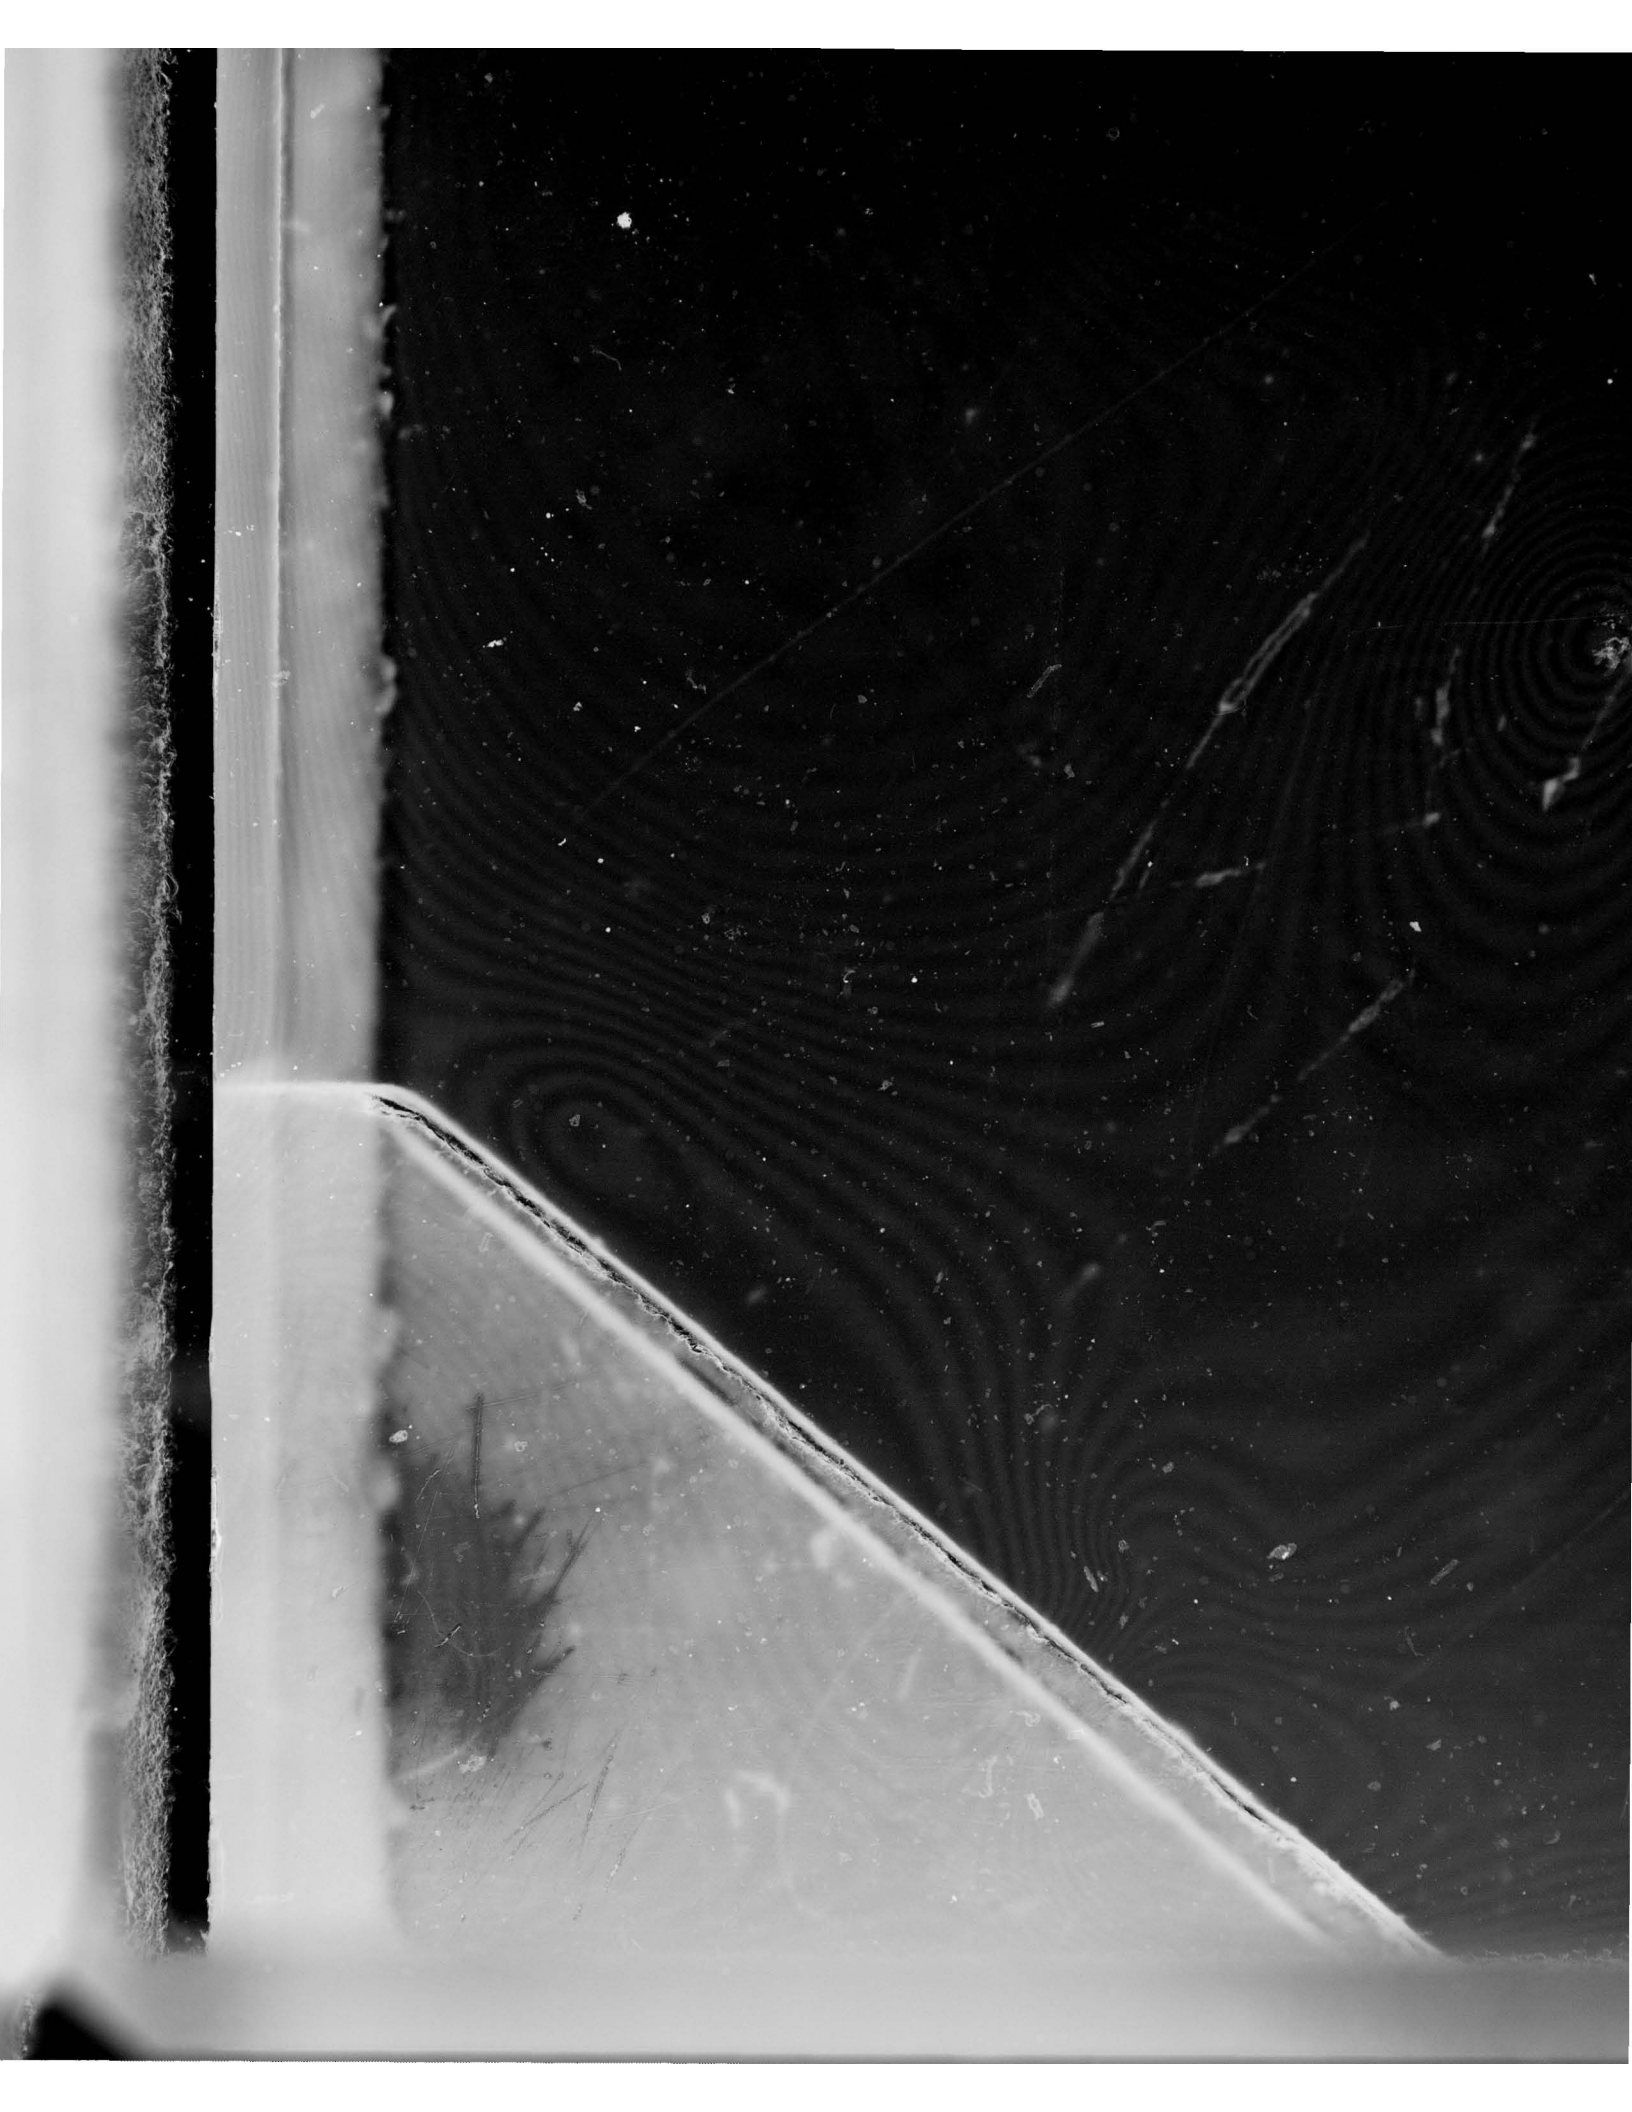
Fig. 13 WOL (LT) Specimen
(1 inch thick)
